Orlando Venues Workshop Presentation

Tinker Field

Tinker Field Condition

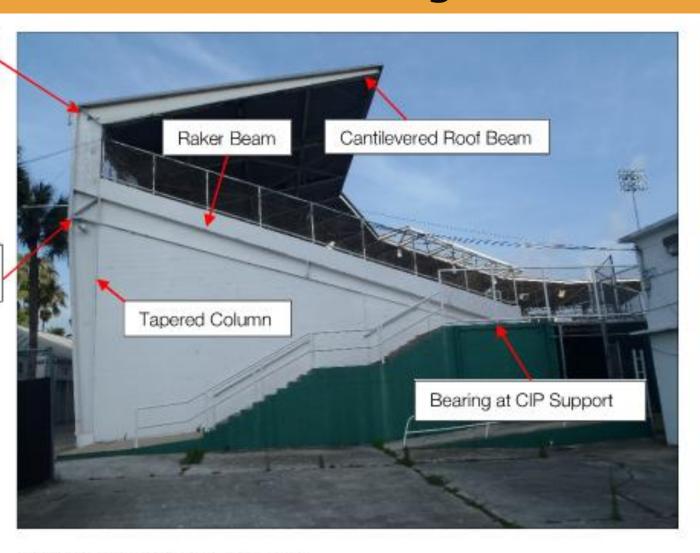
Figure 5: View of existing rigid frame bent.

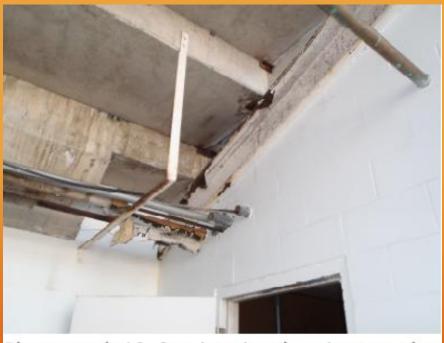
Photograph 19: Seating riser bearing on raker

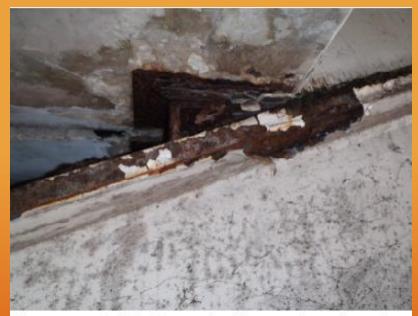
Photograph 20: Corroded bent plate bearing Seats and embeds

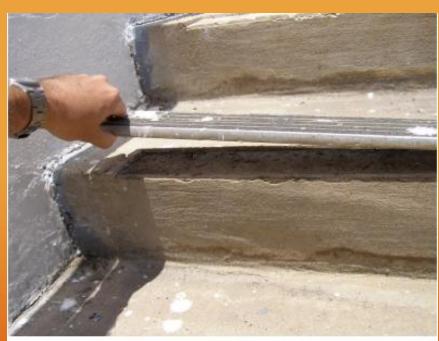
Photograph 23: Loose stair tread nosing

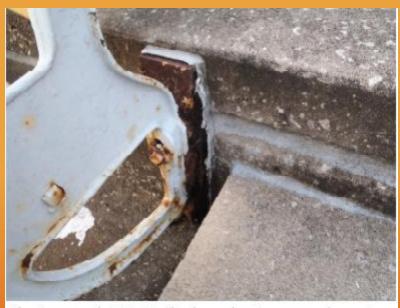
Photograph 26: Failed sealant around seat Anchorage plate

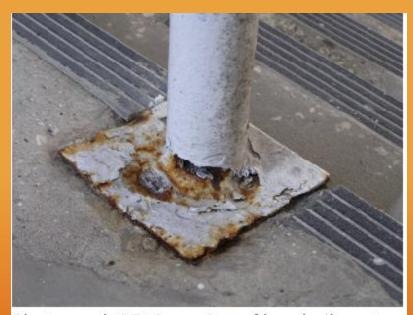
Photograph 27: Corrosion of handrail post Base plate

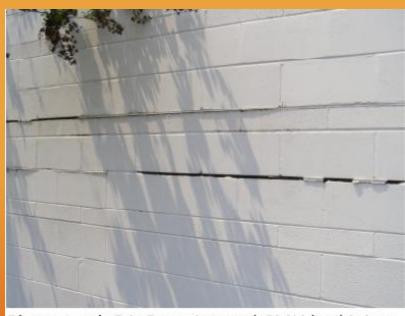
Photograph 34: Deteriorated CMU bed joints

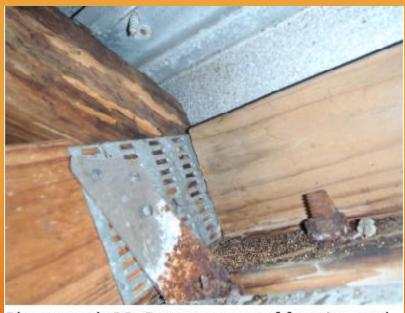
Photograph 38: Damage to roof framing and Connections

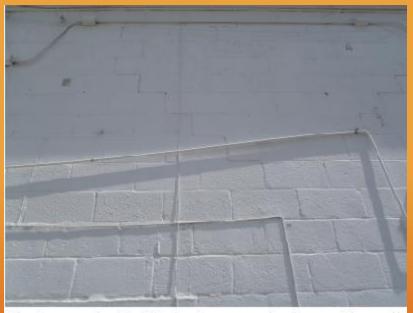
Photograph 41: Stair-step cracks in south wall Of press box building

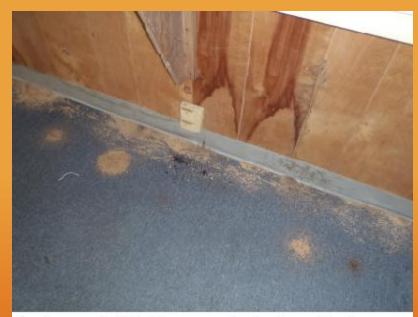
Photograph 43: Appears to be termite frass
On floor

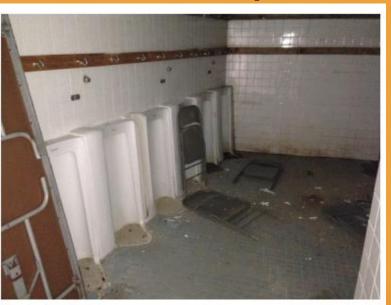
Photo 3-2

Plumbing fixtures taken out of service due to inadequate sanitary lines

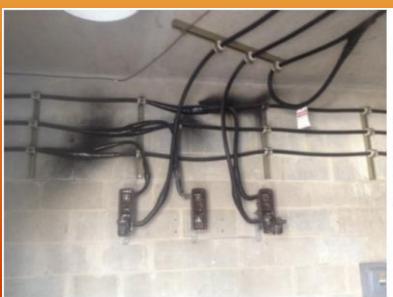
Photo 3-3
Signs of electrical failure in one of the electrical rooms

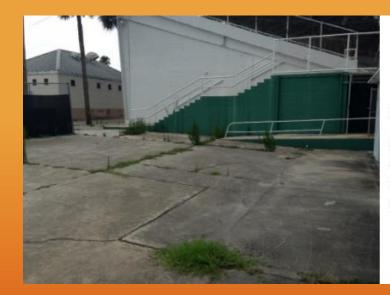
Photo 4-1

Sloping of slabs are too steel, Railing in background do not meet code

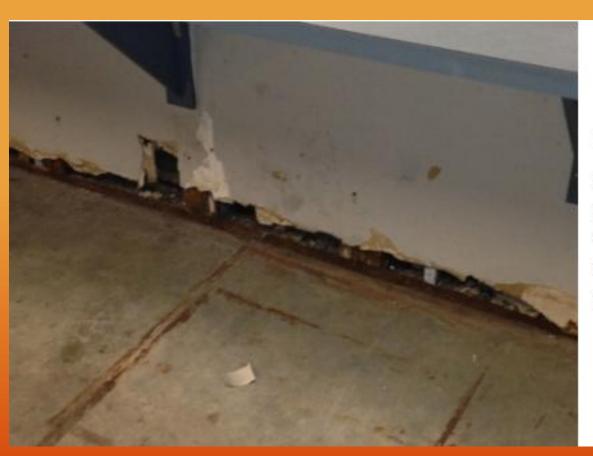
Photo 5-3

Wood framed walls are deteriorated and mold is growing in the drywall (in concession pantry in 1990 building)
